Culvert Rapid Assessment Seward Highway - MP 99 to 105 (Bird to Indian) ADOT&PF State Project No. 33577

Seward Highway MP 99-105 Bird to Indian

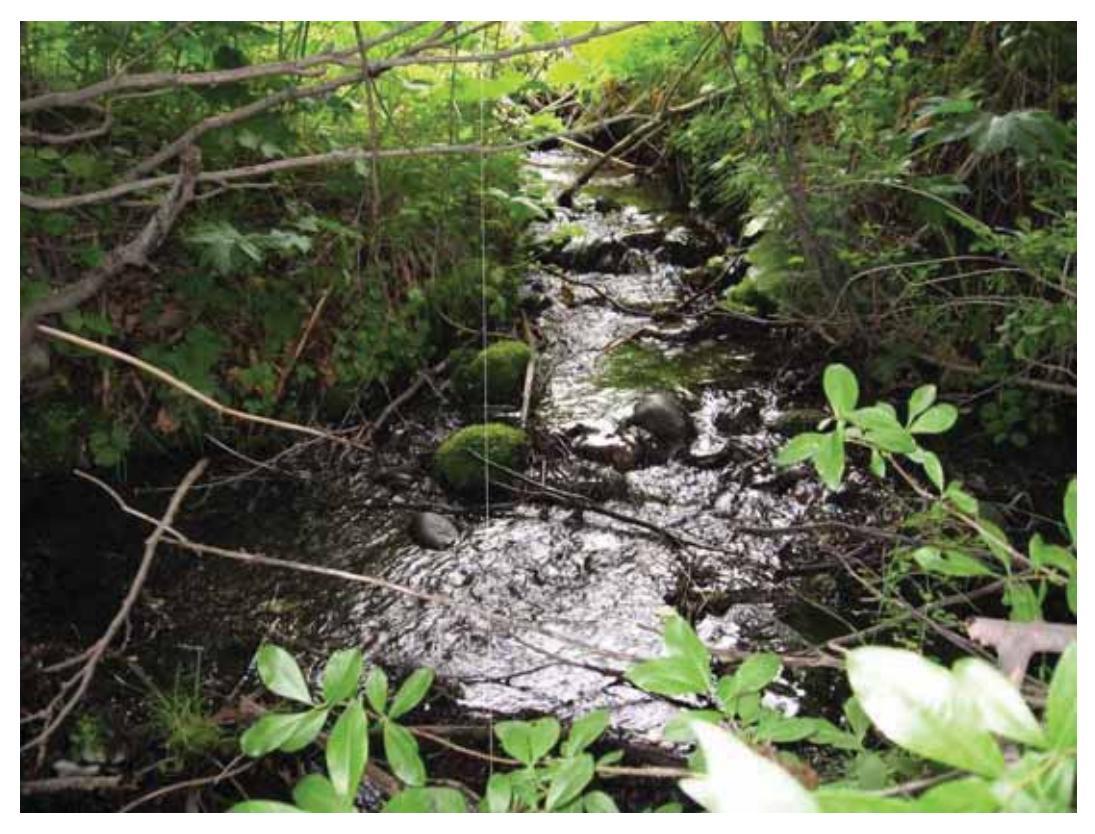
"Ball Field" Creek stream approaching highway culvert

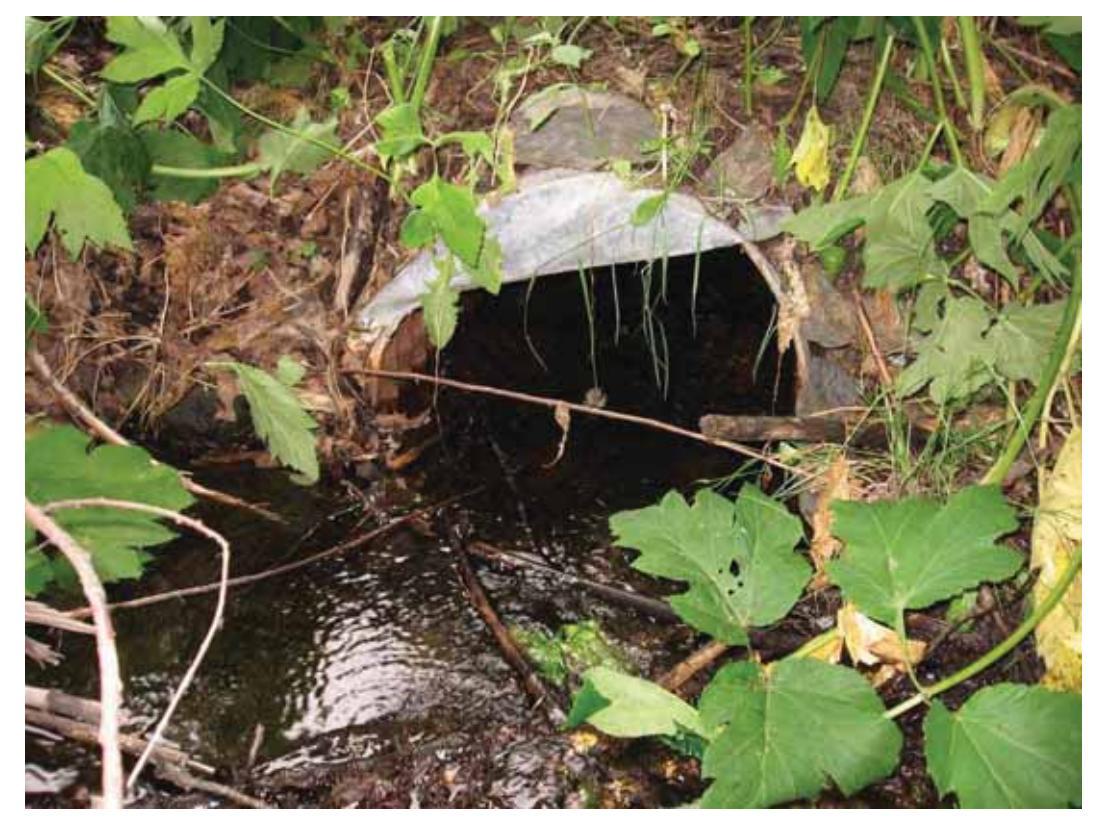
"Ball Field" Creek highway culvert inlet

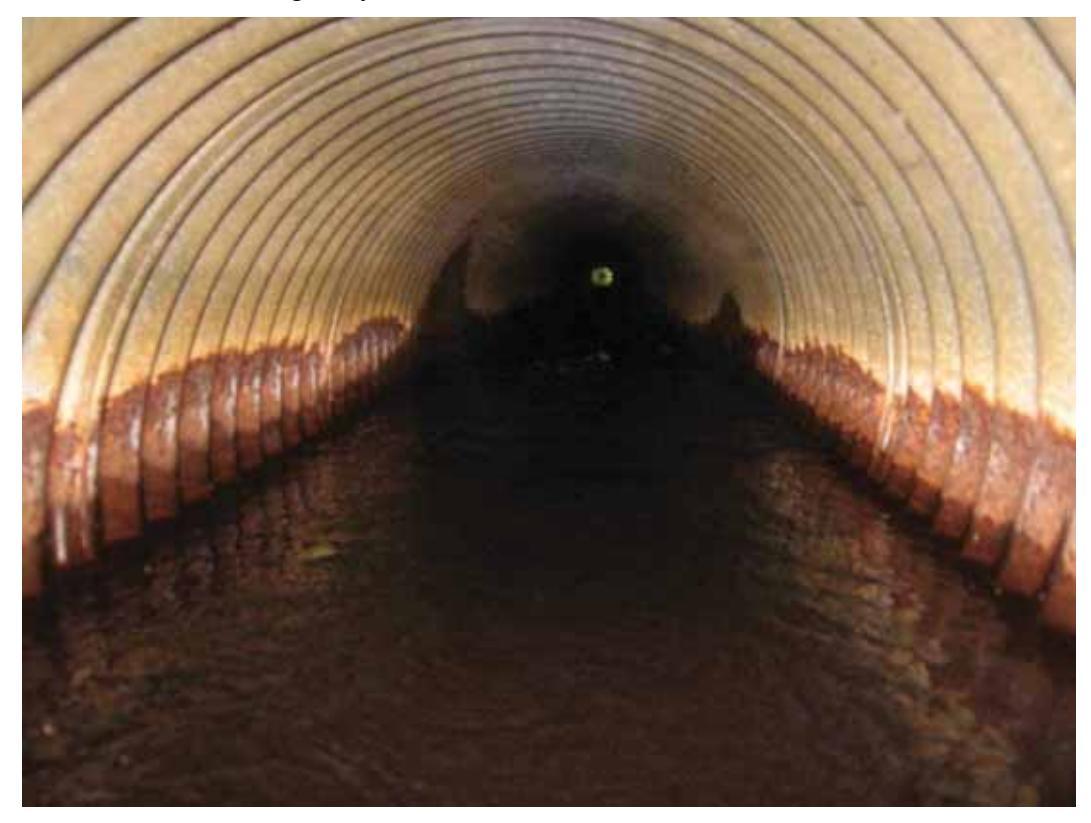
"Ball Field" Creek highway culvert

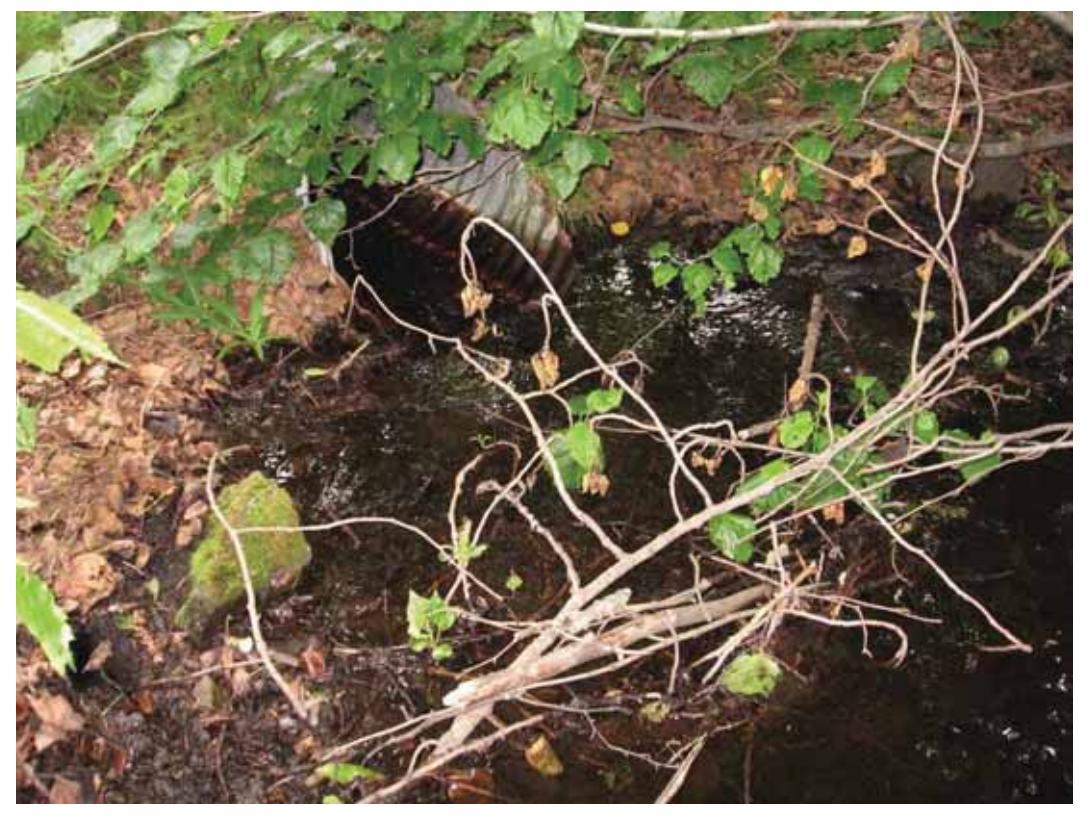
"Ball Field" Creek highway culvert outlet

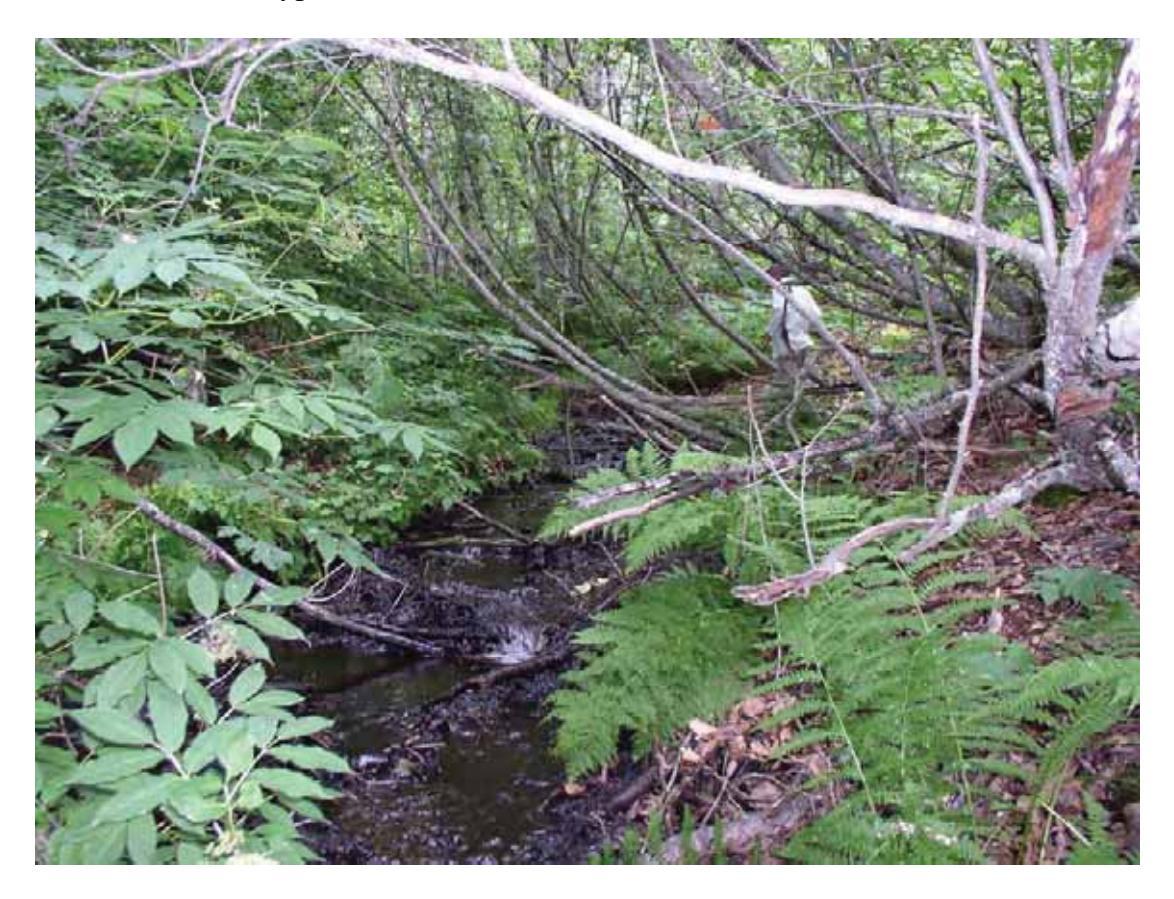
"Ball Field" Creek typical channel condition

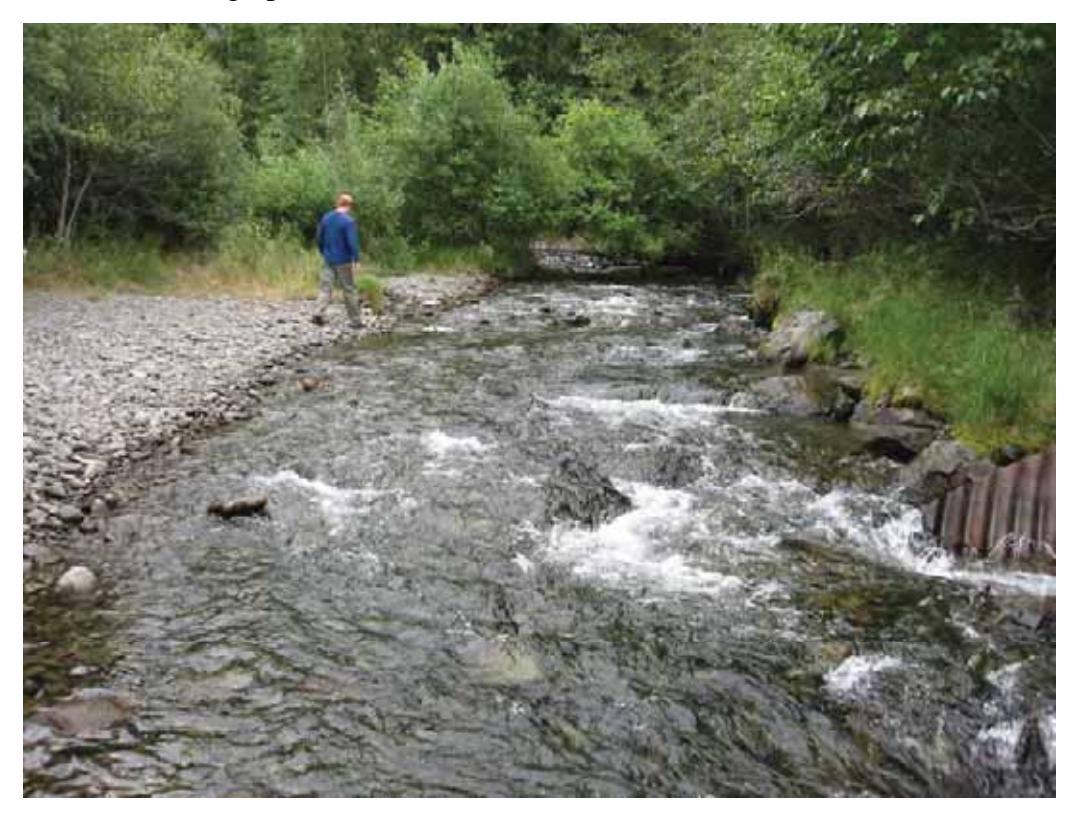
Currently the railroad culverts are perched during low tide, and the combination of rock placement at the outlet and sharp, jagged, decomposed metal make fish access during low tide hazardous, if not highly unlikely. At the time of the survey the tide was low and a substantial number of pink salmon were milling just below the pipes. There were no fish observed attempting to leap the outlet drops. At high tide the pipes would not serve as a barrier to fish passage.

Indian Creek—looking upstream from ARRC culvert inlets

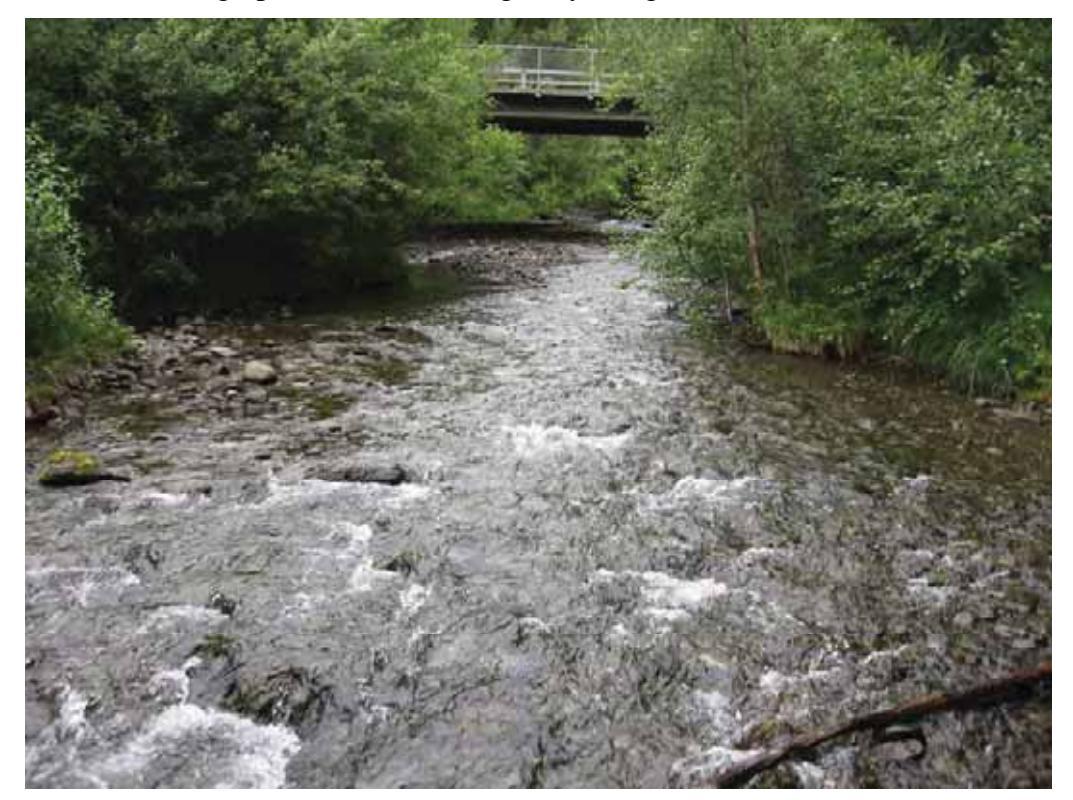
Indian Creek—looking upstream towards highway bridge

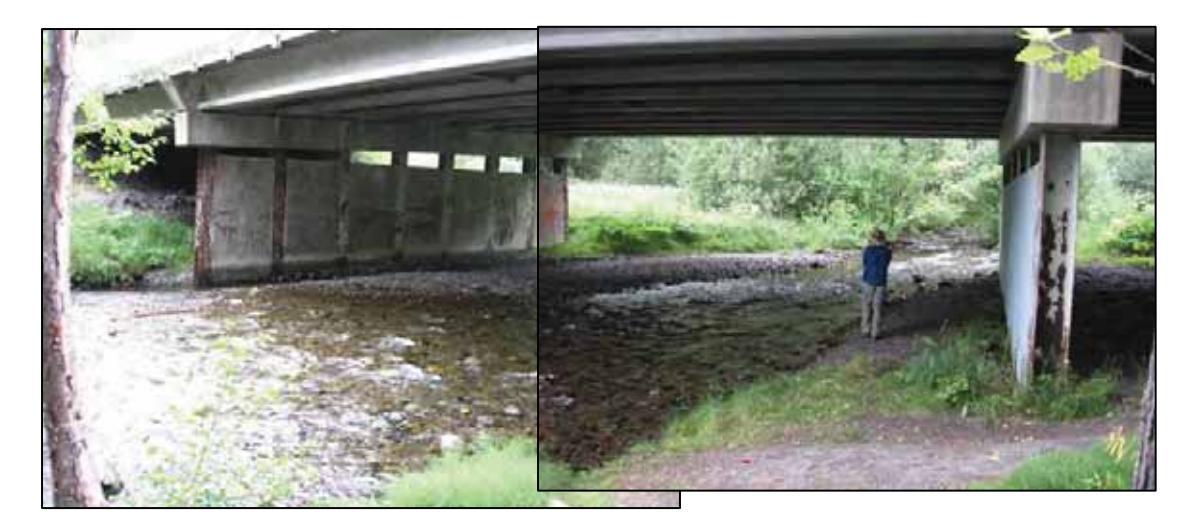
Minor scour was noted along the right (looking downstream) pier where the active flow impinges on the pier mid-section and downstream end. Bridge designs will require locating and configuring piers to minimize scour potential and providing adequate scour protection.

Indian Creek—looking upstream at highway bridge

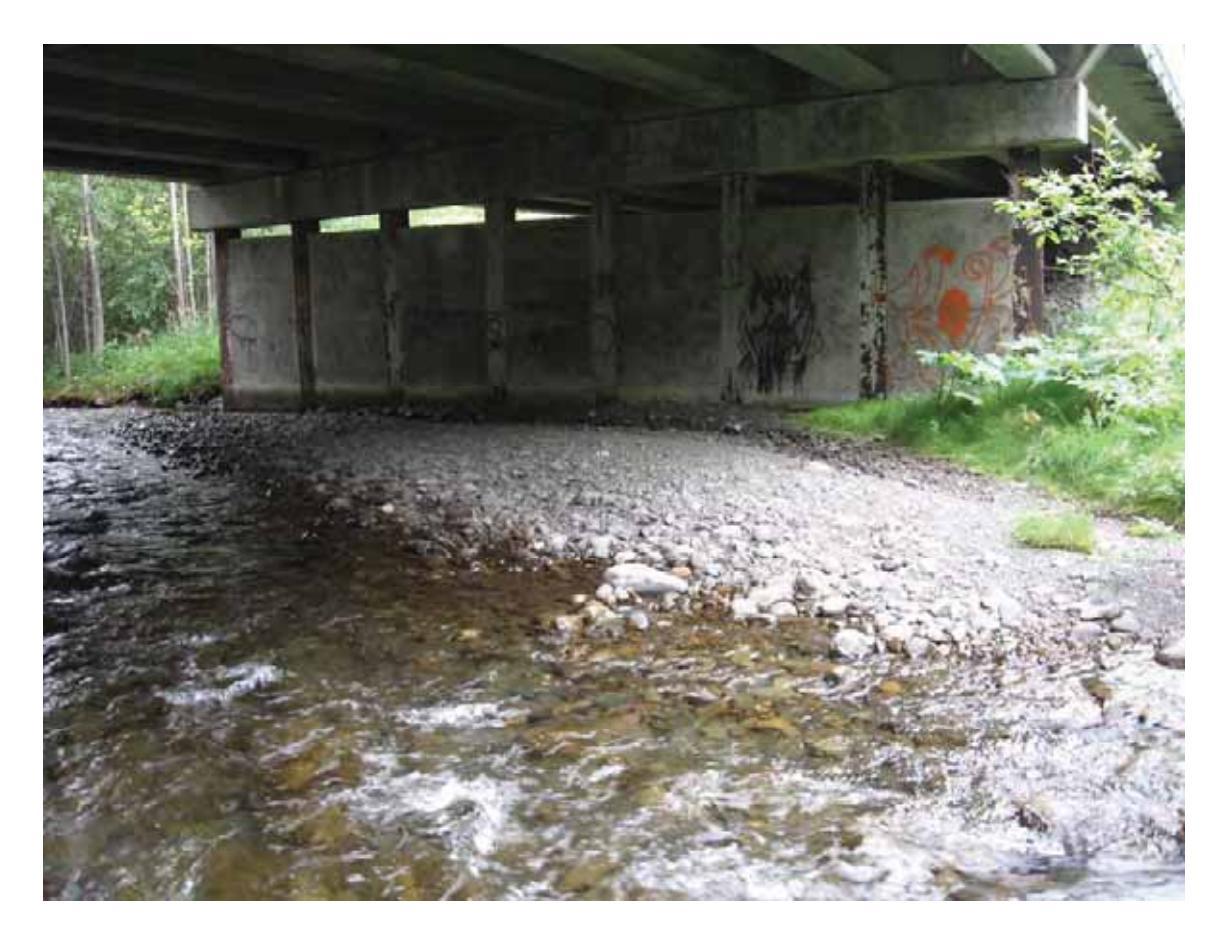
Gravel and small cobble are transported along Indian Creek. A depositional gravel bar is located under the bridge through a locally wider and flatter section of stream. A pebble count of surficial substrate on this bar indicates particles up to 128-mm in size with a D50 (50-percent of the particles, by count, are smaller) equal to 22.6-mm. The gravel bar is slightly armored from fine particles being winnowed from the surface by stream flows leaving a coarser layer of sediment. Other reaches of Indian Creek that are narrower or steeper tend to be transport reaches with this size of sediment absent.

Indian Creek—looking downstream at gravel bar at highway bridge

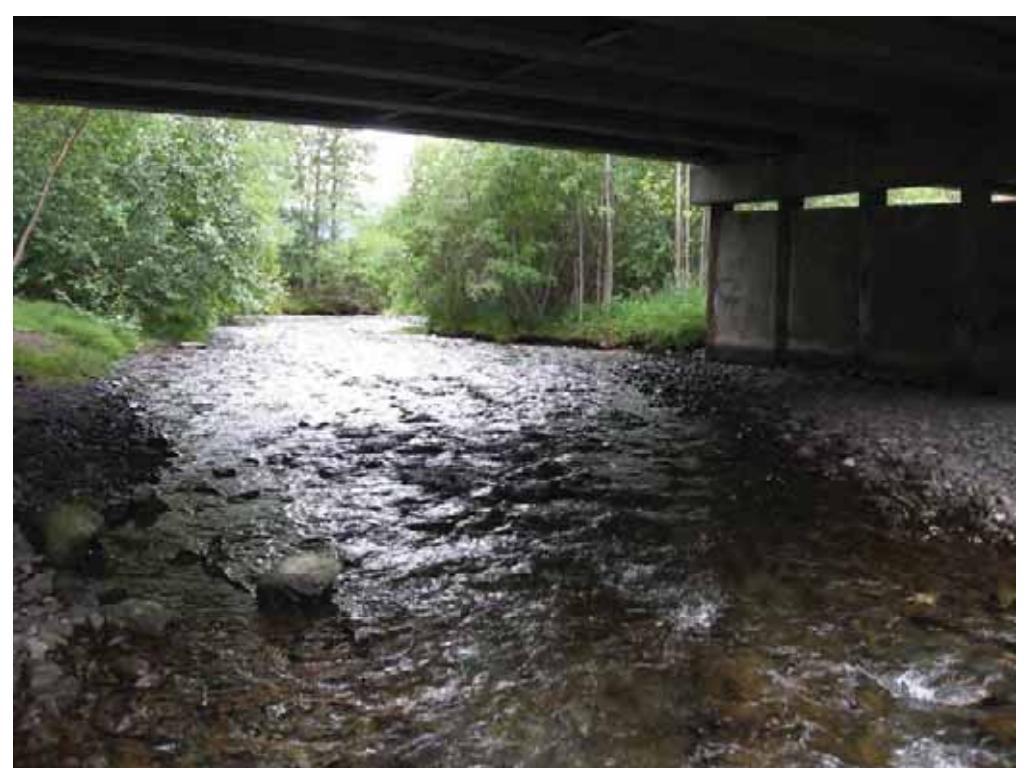
Indian Creek—looking downstream through highway bridge

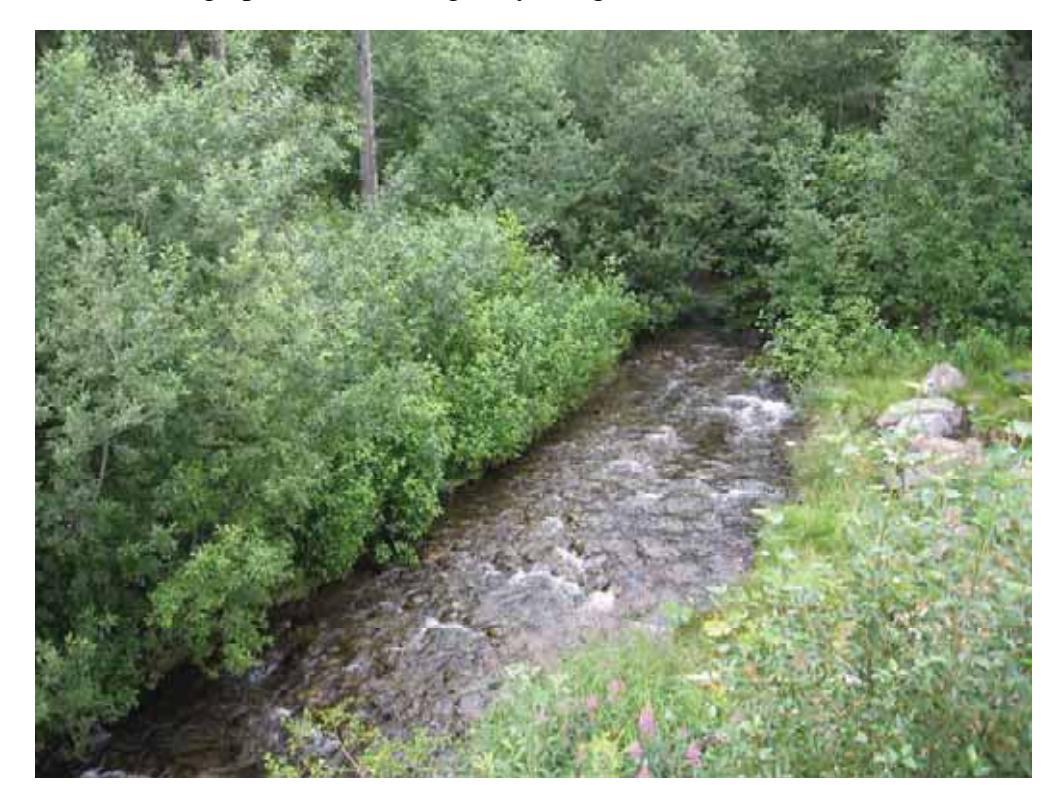
Indian Creek—looking upstream from highway bridge

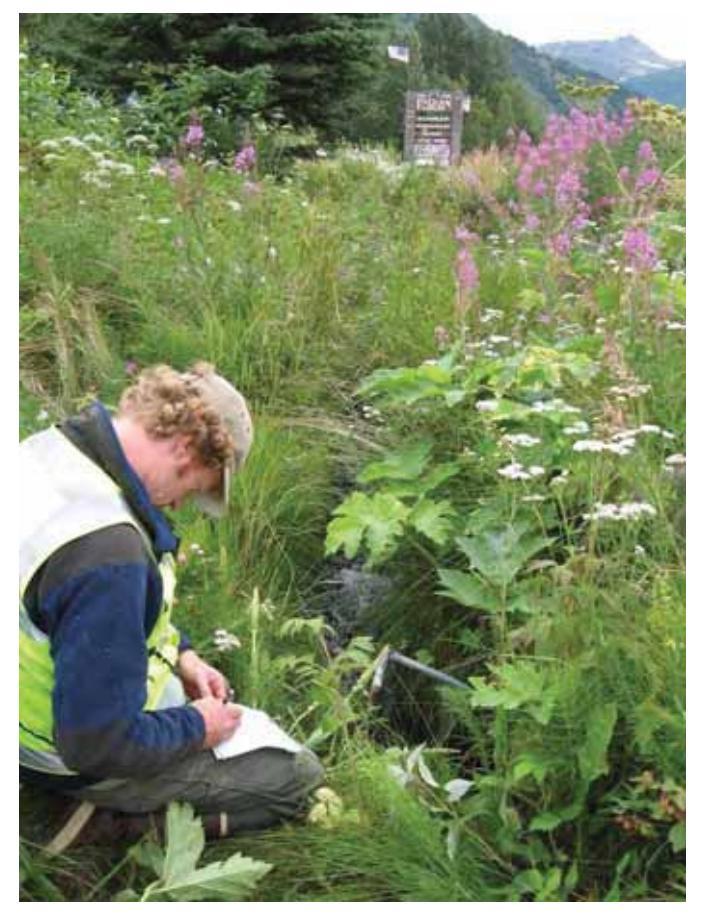
"Subdivision" Creek looking upstream from inlet to highway culvert

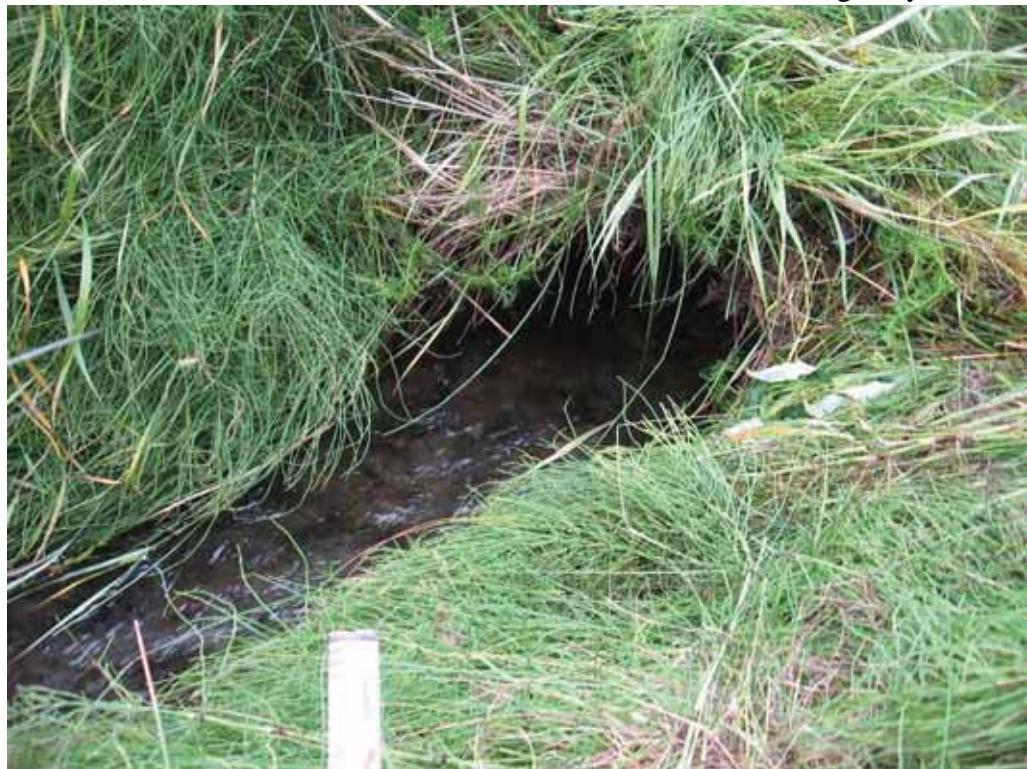
From the site visit conducted in August 2006, a rapid assessment by visual inspection and simple measurements was completed. The existing culvert is a 24-inch CMP with no stream substrate material in the bottom of the pipe. The bottom of the pipe is rusted with a stain line to 1.8-ft depth at the inlet. Flow was observed to a depth 0.3-ft to 0.5-ft at the inlet and outlet, respectively. The outlet is slightly squashed. A follow up survey of culvert inlet/outlet and stream profile and cross section were completed at a later date by DOWL HKM surveyors. From the site survey, the existing pipe is approximately 79-ft long at 0.1007-ft/ft slope.

"Subdivision" Creek—outlet from highway culvert

A 4'9"x3'2" pipe arch is recommended as the replacement at the frontage road and highway crossings. As described above, the Tier 1 (stream simulation) method was selected for design of fish passage through the new culverts. This size pipe will satisfy requirements of the Tier 1 design method for fish passage as stated in the MOA. This culvert will provide sufficient span to accommodate the average of channel widths surveyed upstream and downstream of the culvert of about 4-ft and 6-ft, respectively.

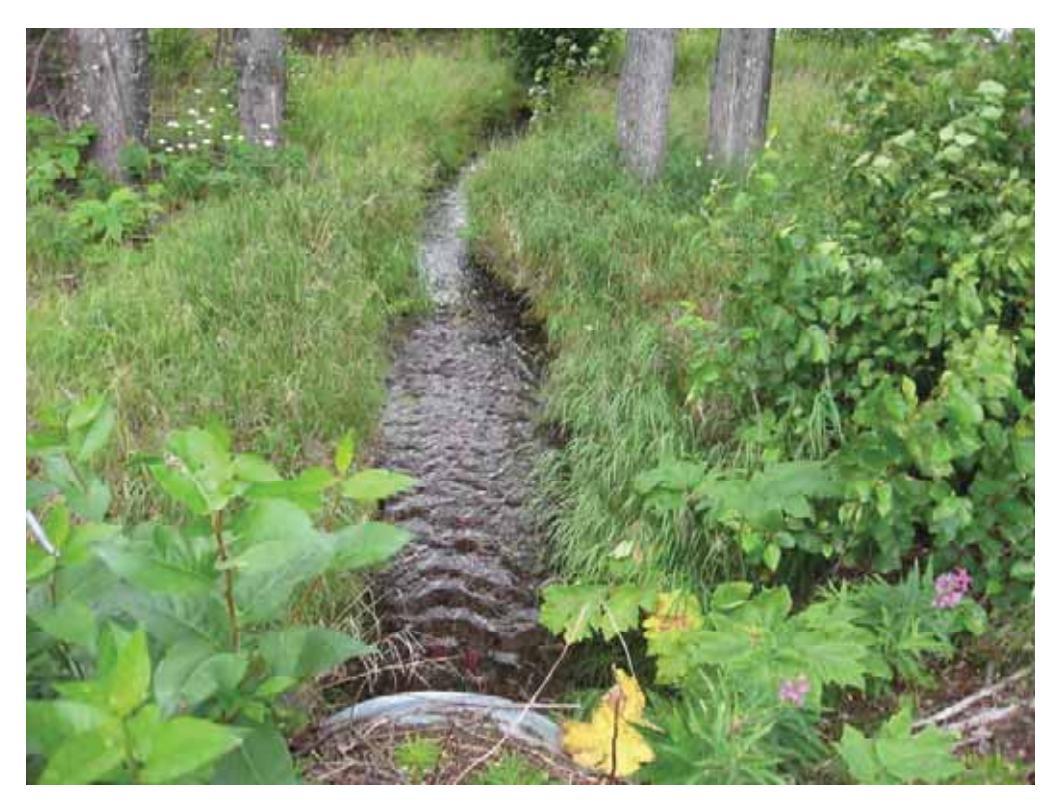
"Subdivision" Creek-Stream below ARRC

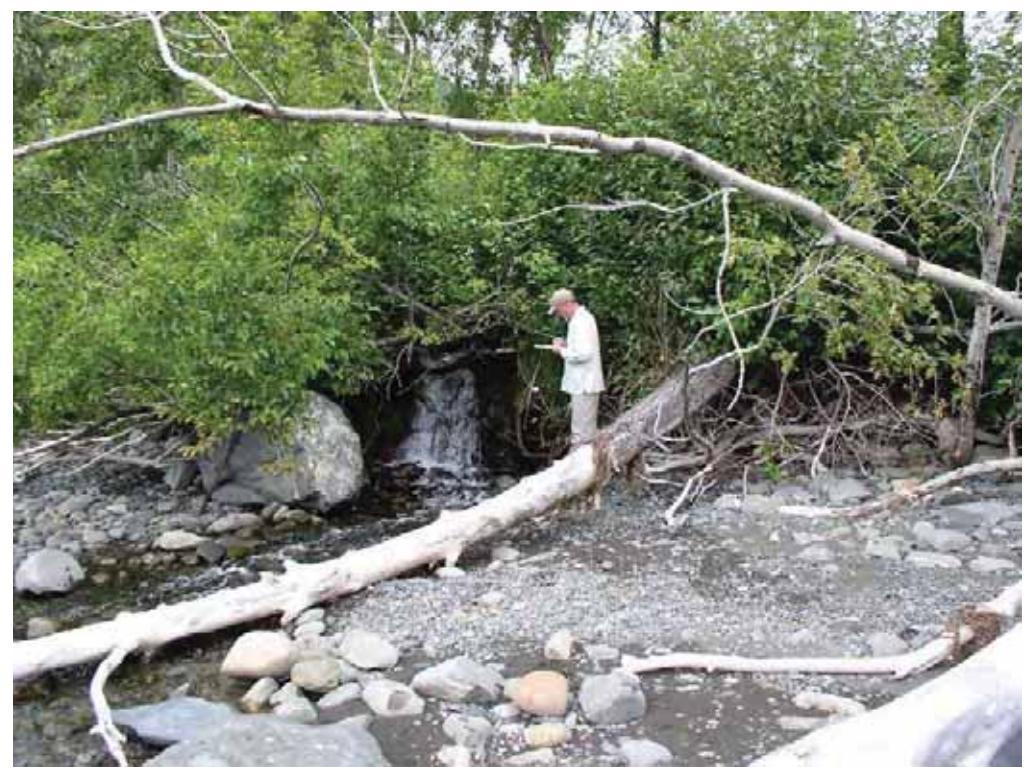
"Subdivision" Creek—Waterfall at Turnagain Arm shoreline
