APPENDIX A

Data Sheets and Sample Site Photographs

Project/Site: Seward Highway MP 99 - 105 Borough/City: Anchorage Sampling Date: August 8, 2006

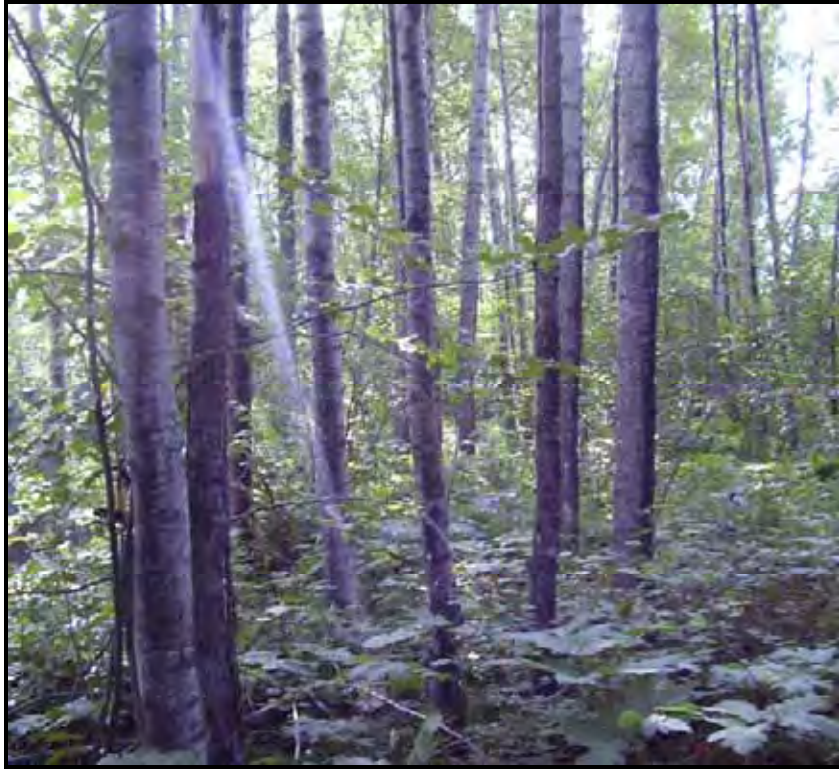
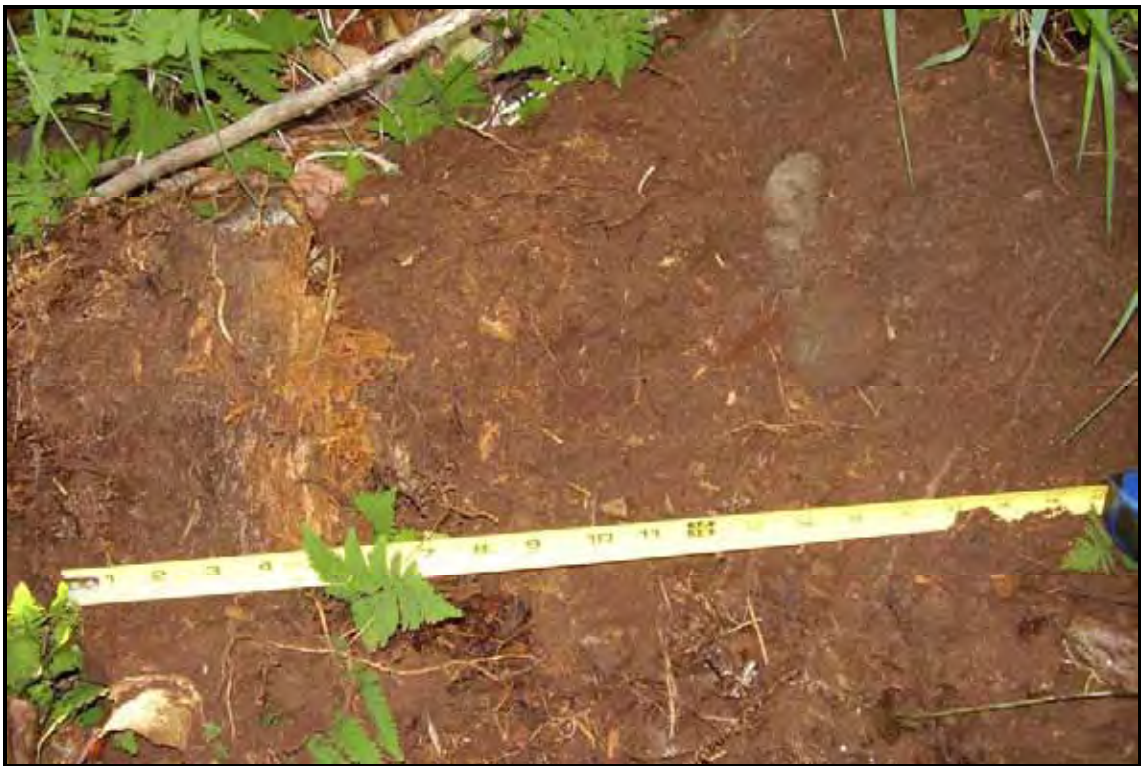
Hydrophytic Vegetation Present?	Yes _____ No <u>✓</u>	Is the Sampled Area within a Wetland?	Yes _____ No <u>✓</u>
Hydric Soil Present?	Yes _____ No <u>✓</u>		
Wetland Hydrology Present?	Yes _____ No <u>✓</u>		
Remarks: Hydrology - the winter storage this year is half of the average, so wetland areas may be drier compared to last year. The site is adjacent to a bike path and the highway. There is a creek approximately 20 feet away. Creek is deep cut.

Remarks:
Very loamy, fully soil. Can't hold water.

Field Observations: Surface Water Present? Yes _____ No <input checked="" type="checkbox"/> Depth (inches): _____ Water Table Present? Yes _____ No <input checked="" type="checkbox"/> Depth (inches): _____ Saturation Present? Yes _____ No <input checked="" type="checkbox"/> Depth (inches): _____ (includes capillary fringe)		Wetland Hydrology Present? Yes _____ No <input checked="" type="checkbox"/>
Describe Recorded Data (stream gauge, monitoring well, aerial photos, previous inspections), if available:		
Remarks: Dry

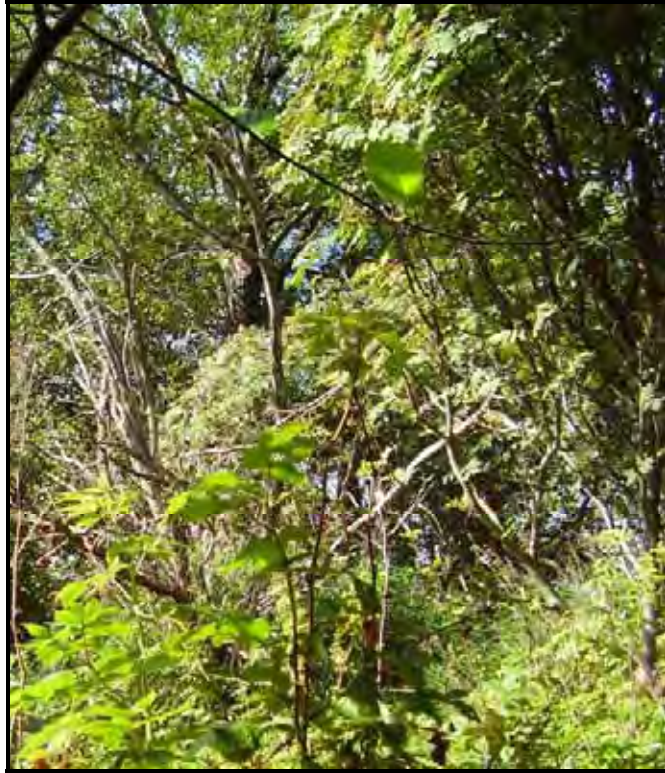
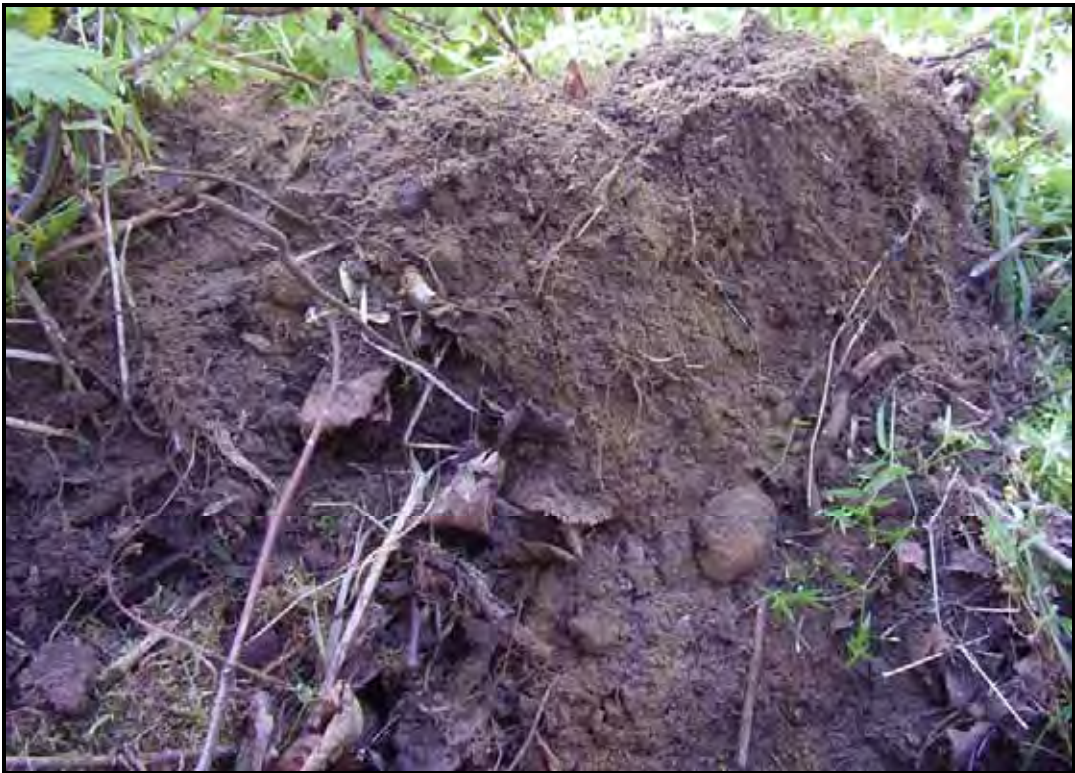
Hydrophytic Vegetation Present? Yes _____ No <input checked="" type="checkbox"/>	Is the Sampled Area within a Wetland? Yes _____ No <input checked="" type="checkbox"/>
Hydric Soil Present? Yes _____ No <input checked="" type="checkbox"/>	
Wetland Hydrology Present? Yes _____ No <input checked="" type="checkbox"/>	
<p>Remarks:</p> <p>hydrology - the winter storage this year is half of the average, so wetland areas may be drier compared to last year.</p> <p>Approximately 20 feet from site the hill starts to get very steep. Tall cottonwoods are along the edge of the beach.</p> <p>Waypoint 37</p> <p>Closed Tall Shrub. 80% cover.</p>

<input type="checkbox"/> Thick Dark Surface (A12)							
<input type="checkbox"/> Alaska Gleyed (A13)			³ One indicator of hydrophytic vegetation, one primary indicator of wetland hydrology,				
<input type="checkbox"/> Alaska Redox (A14)			and an appropriate landscape position must be present.				
<input type="checkbox"/> Alaska Gleyed Pores (A15)			⁴ Give details of color change in Remarks.				
Restrictive Layer (if present):							
Type: _____							
Depth (inches): _____							
						Hydric Soil Present? Yes _____ No <input checked="" type="checkbox"/>	
Remarks:							
Really red soil.

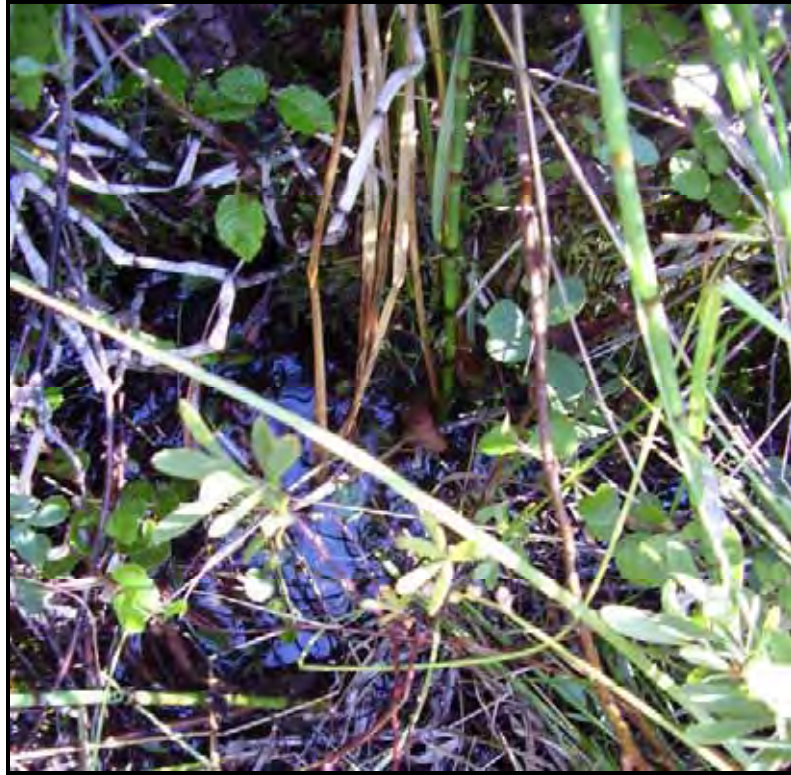
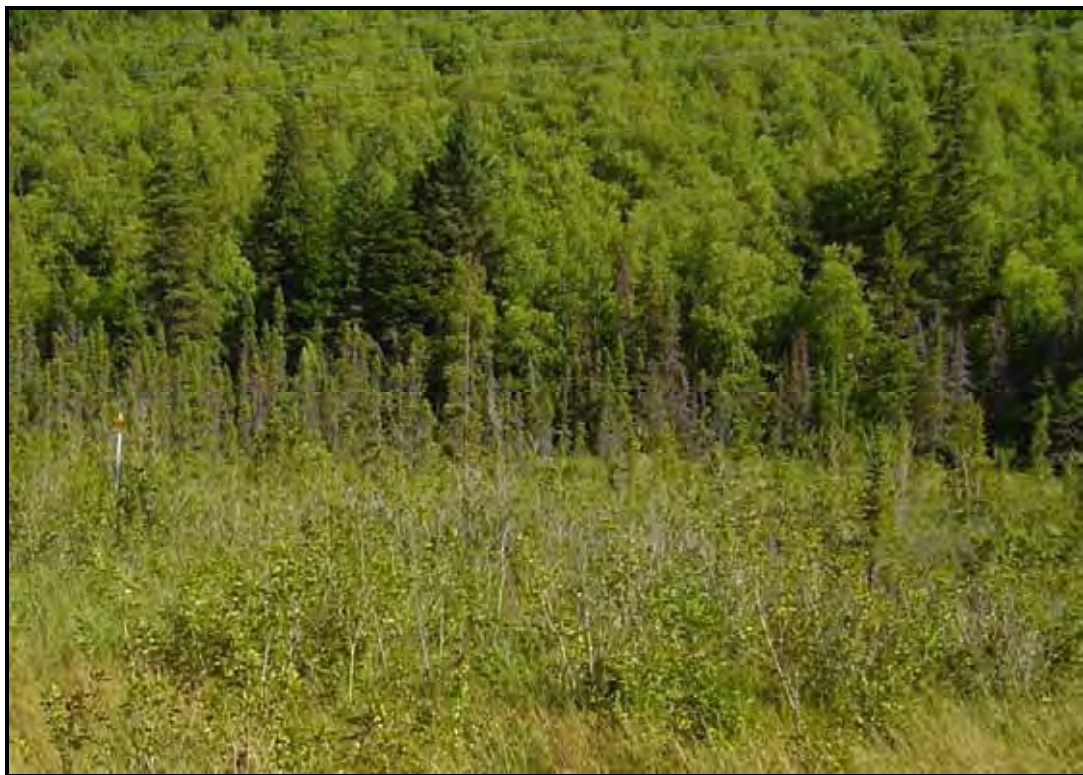
Hydrophytic Vegetation Present?	Yes <input checked="" type="checkbox"/>	No <input type="checkbox"/>	Is the Sampled Area within a Wetland?	Yes <input checked="" type="checkbox"/>	No <input type="checkbox"/>
Hydric Soil Present?	Yes <input checked="" type="checkbox"/>	No <input type="checkbox"/>			
Wetland Hydrology Present?	Yes <input checked="" type="checkbox"/>	No <input type="checkbox"/>			
Remarks: hydrology - the winter storage this year is half of the average, so wetland areas may be drier compared to last year. Site is adjacent to the highway. Waypoint 39 Shrub low open

18. <i>Carex canescens</i>	15	OBL
19. <i>Eriophorum angustifolium</i>	10	OBL
20. _____	_____	_____
Total Cover: 355		
Plot size 30-foot circle _____	% Bare Ground 0	
% Cover of Wetland Bryophytes 0	Total Cover of Bryophytes 0	
Remarks: Alders are growing on hummocks.

Remarks:
Hydric soils assumed due to hydrophytic vegetation and hydrology.

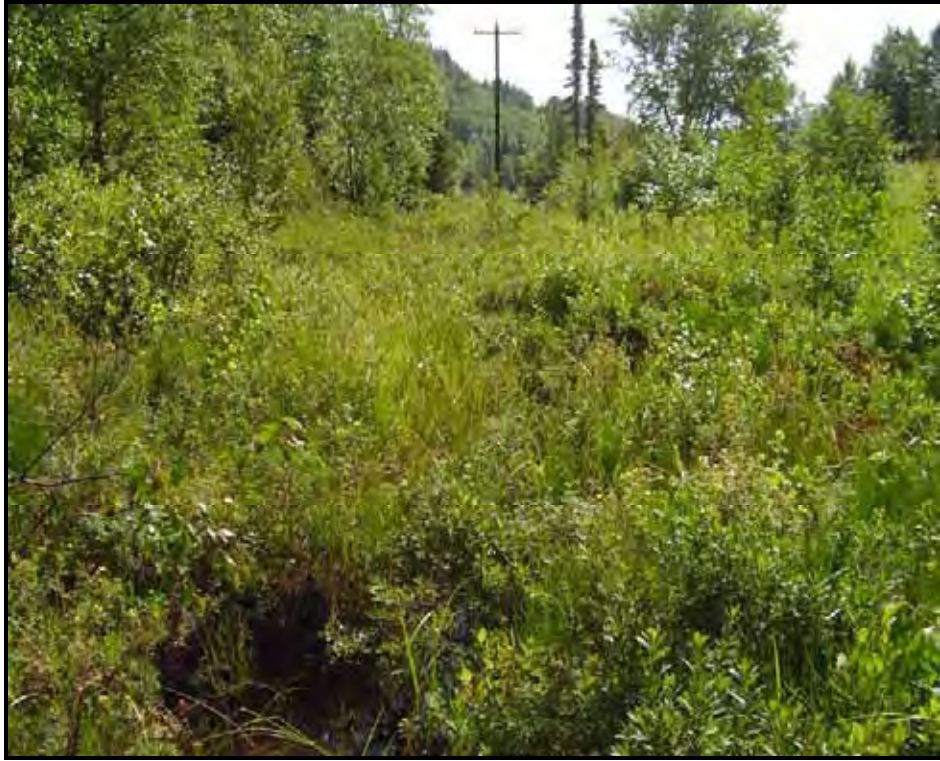
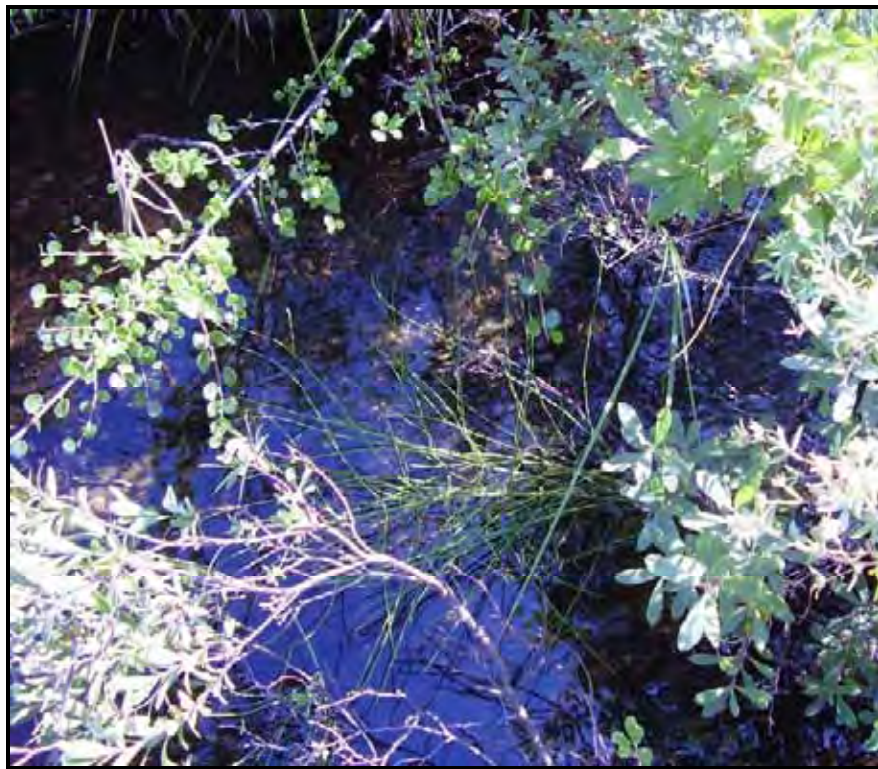
Hydrophytic Vegetation Present?	Yes <u>✓</u> No <u></u>	Is the Sampled Area within a Wetland?	Yes <u>✓</u> No <u></u>
Hydric Soil Present?	Yes <u>✓</u> No <u></u>		
Wetland Hydrology Present?	Yes <u>✓</u> No <u></u>		
Remarks: Hydrology - the winter storage this year is half of the average, so wetland areas may be drier compared to last year. Site is adjacent to the highway. Open low shrub. 35% cover. Waypoint 41

Remarks:
Tussocks. No bare ground - plants occupying every space available.

Field Observations: Surface Water Present? Yes <input checked="" type="checkbox"/> No <input type="checkbox"/> Depth (inches): 0-6 Water Table Present? Yes <input checked="" type="checkbox"/> No <input type="checkbox"/> Depth (inches): _____ Saturation Present? Yes <input checked="" type="checkbox"/> No <input type="checkbox"/> Depth (inches): 0 (includes capillary fringe)		Wetland Hydrology Present? Yes <input checked="" type="checkbox"/> No <input type="checkbox"/>
Describe Recorded Data (stream gauge, monitoring well, aerial photos, previous inspections), if available:		
Remarks: Tributary has very clear water. Area adjacent to creek is very saturated and spongy. Water between tussocks.

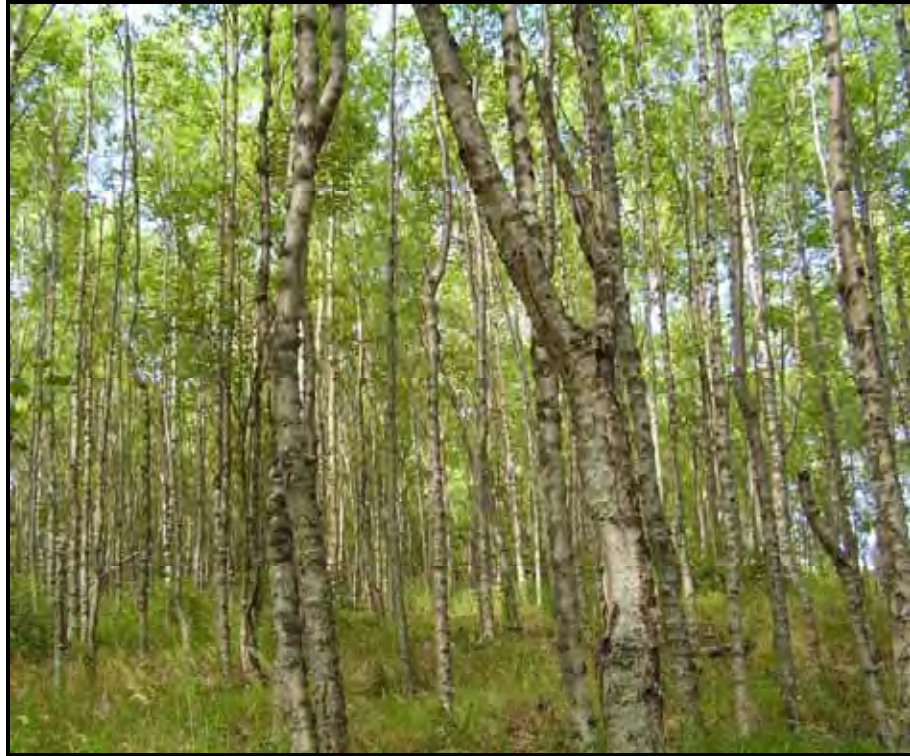
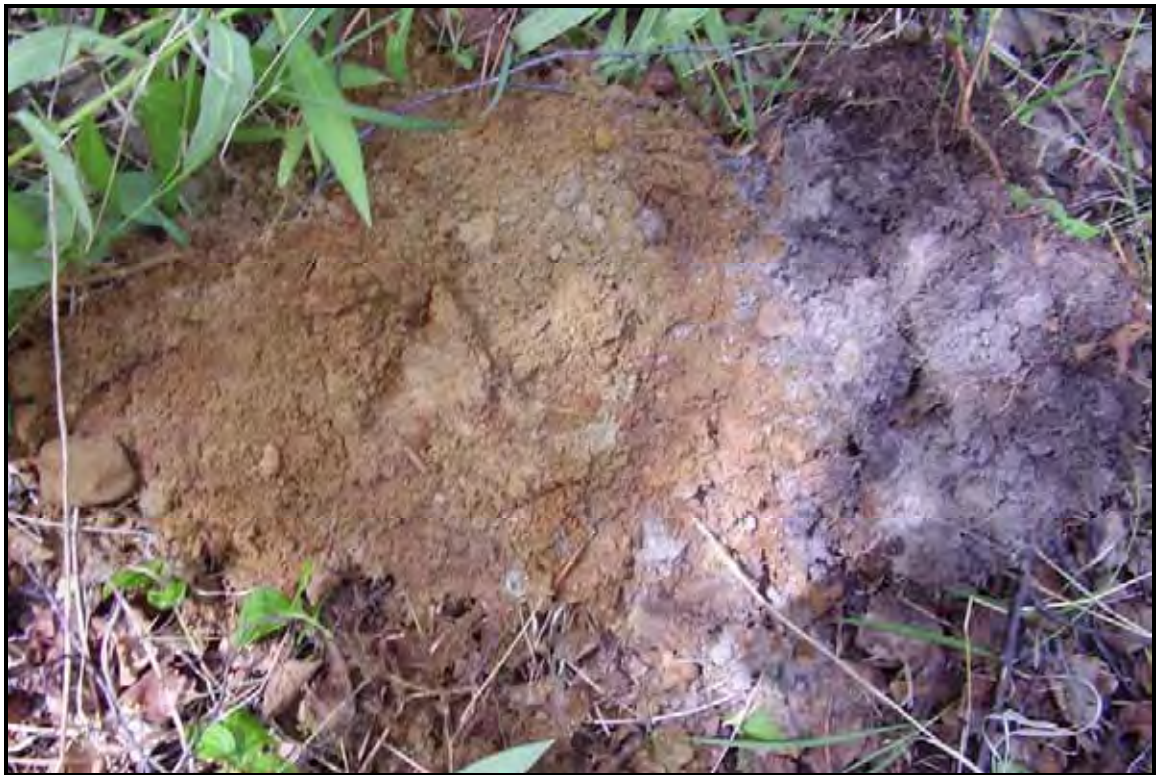
Profile Description: (Describe to the depth needed to document the indicator.)								
Depth (inches)	Matrix		Redox Features				Texture	Remarks
	Color (moist)	%	Color (moist)	%	Type ¹	Loc ²		
0-3								O layer - root wad
3-4	10YR 3/2	100					silty loam	ash layer
4-7	10YR3/4	100					sandy loam	tightly packed cobbles with interstitial red soil
7-20	10YR3/4	100					sandy loam	some gravel

Remarks:
Dry

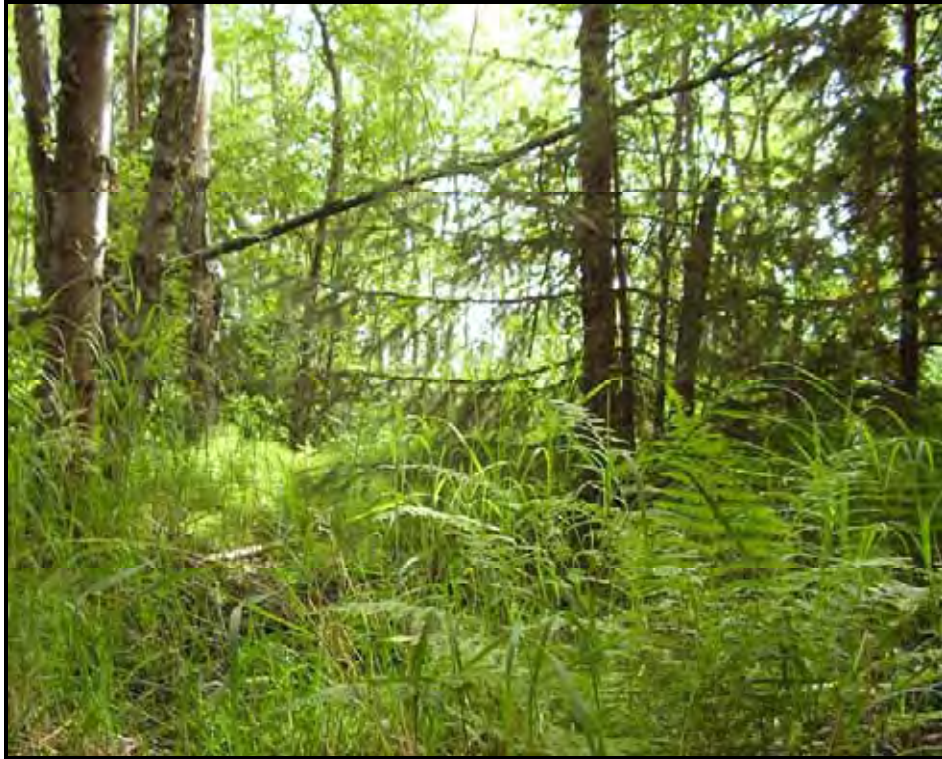
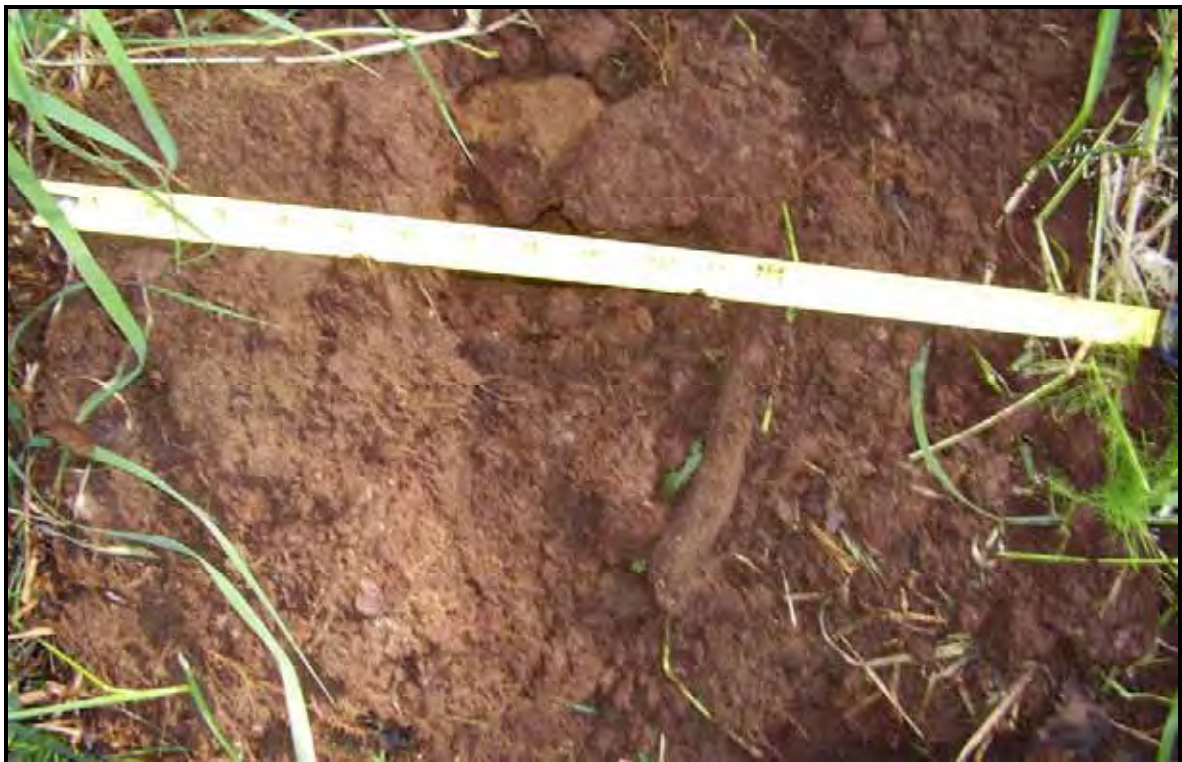
Hydrophytic Vegetation Present? Yes _____ No <input checked="" type="checkbox"/>	Is the Sampled Area within a Wetland? Yes _____ No <input checked="" type="checkbox"/>
Hydric Soil Present? Yes _____ No <input checked="" type="checkbox"/>	
Wetland Hydrology Present? Yes <input checked="" type="checkbox"/> No _____	
<p>Remarks:</p> <p>Hydrology - the winter storage this year is half of the average, so wetland areas may be drier compared to last year.</p> <p>This point seems to provide seasonal drainage, as evidenced by a culvert nearby under the trail. Water stained leaves and other hydrologic indicators suggest a wetland, but no hydric soils have developed and with the exception of the sedge, the plants are upland indicators. BPJ is that the trail (<10 years old) impounds water and is directing flow into a drainage channel.</p> <p>across Waypoint 44</p> <p>Closed Mixed Forest</p>

15. _____	_____	_____		
16. _____	_____	_____		
17. _____	_____	_____		
18. _____	_____	_____		
19. _____	_____	_____		
20. _____	_____	_____		
Total Cover: 190				
Plot size 30 foot swath	% Bare Ground 40			
% Cover of Wetland Bryophytes 0	Total Cover of Bryophytes 0			
<p>Hydrophytic Vegetation Present? Yes <input checked="" type="checkbox"/> No _____</p>				
<p>Remarks:</p> <p>Water stained leaves covered the bare ground. The larch are on the peripheral and on hummocks. The birch are going in the middle of the site on hummocks.</p>

Profile Description: (Describe to the depth needed to document the indicator.)							
Depth (inches)	Matrix		Redox Features			Texture	Remarks
	Color (moist)	%	Color (moist)	%	Type ¹		
0 - 2							Root wad
2 - 20	10YR 2/1	100	N/A			silty loam	organic soil

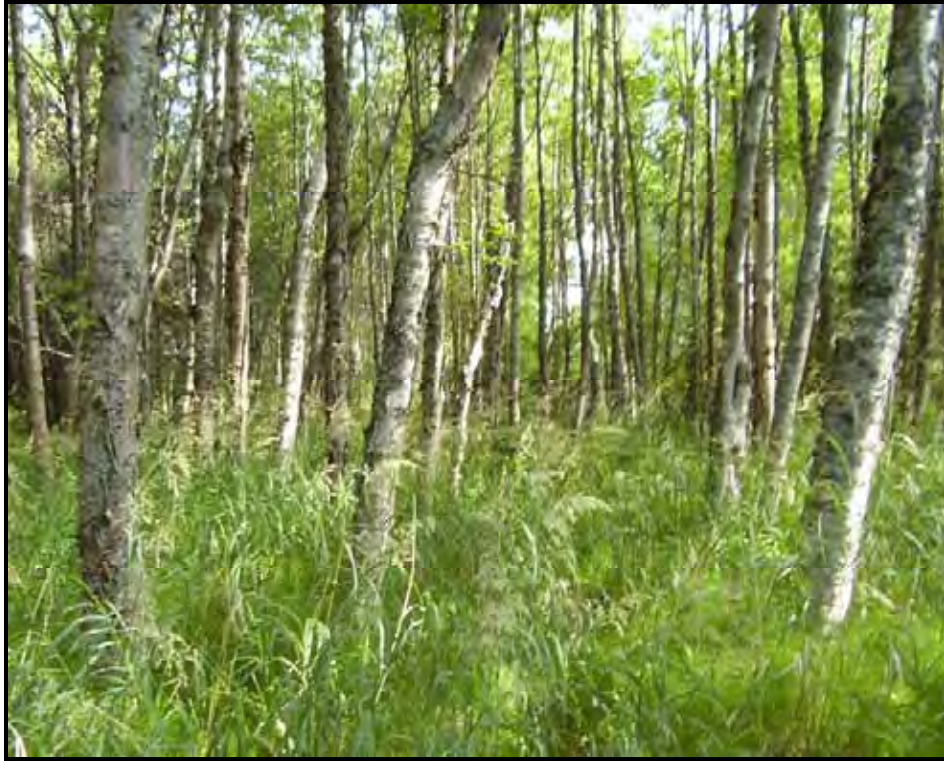
17. _____	_____	_____		
18. _____	_____	_____		
19. _____	_____	_____		
20. _____	_____	_____		
<p>Total Cover: <u>225</u></p> <p>Plot size <u>20 foot diameter circle</u> % Bare Ground <u>15</u></p> <p>% Cover of Wetland Bryophytes <u>0</u> Total Cover of Bryophytes <u>0</u></p>			<p>Remarks:</p> <p>Water stained leaves covered the ground. The viola is patchy.</p>

Profile Description: (Describe to the depth needed to document the indicator.)							
Depth (inches)	Matrix		Redox Features			Texture	Remarks
	Color (moist)	%	Color (moist)	%	Type ¹		
0 - 8							root matter. accoridian.
8 - 20	10YR 2/1	100	N/A				organic soil

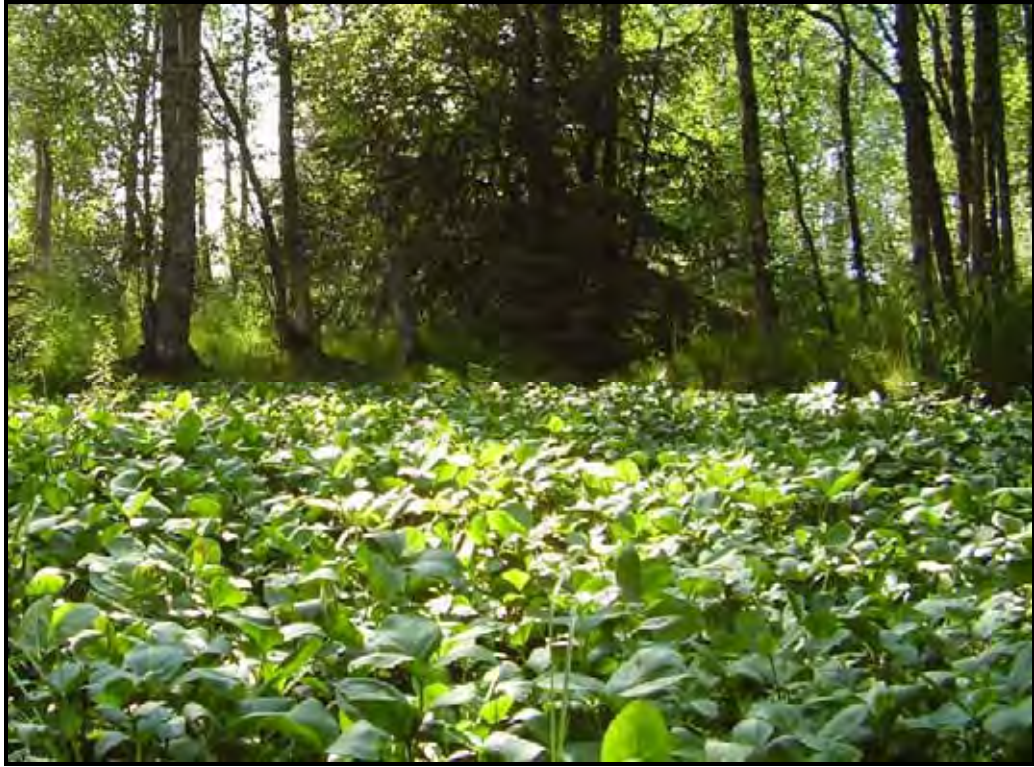
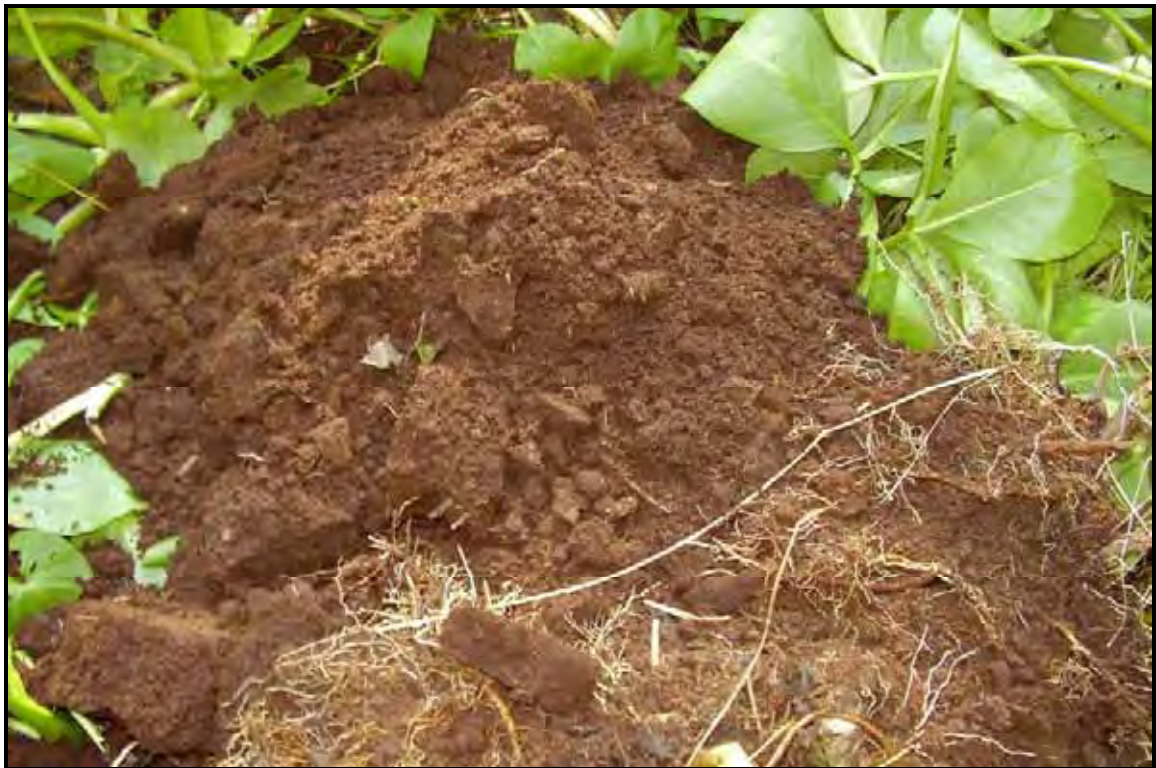
Remarks:
 Grounds was cover in water stained leaves.

Profile Description: (Describe to the depth needed to document the indicator.)							
Depth (inches)	Matrix		Redox Features			Texture	Remarks
	Color (moist)	%	Color (moist)	%	Type ¹		
0 - 7							Root wad with organics
7 - 20	10YR 2/1	100	N/A			silty loam	organic soil

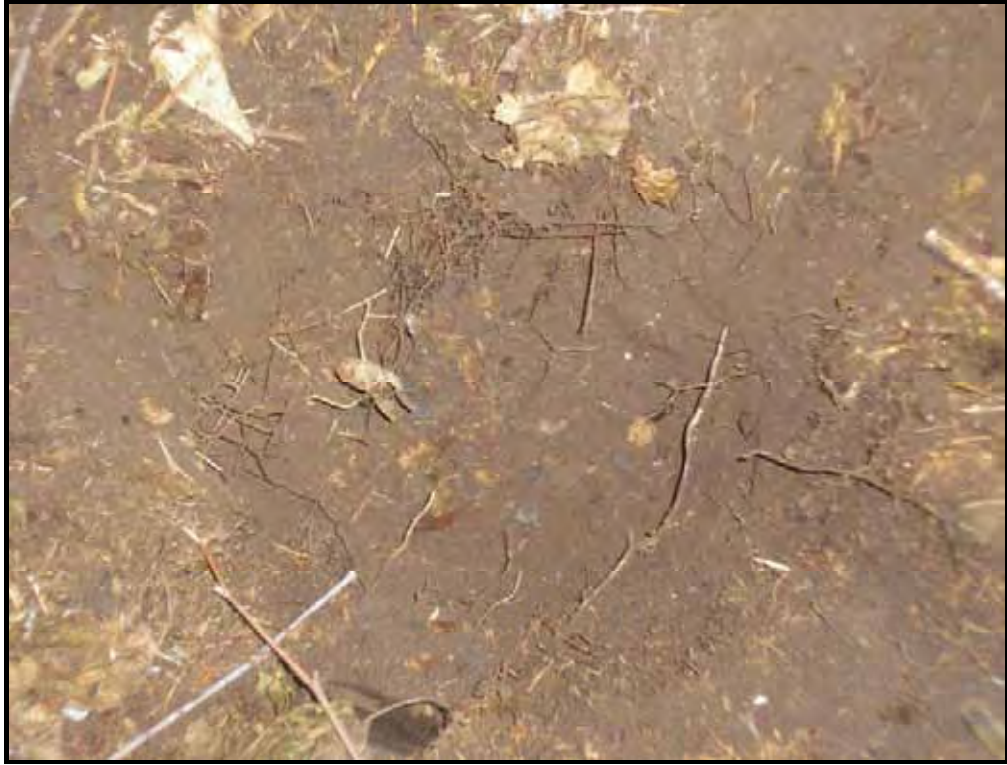
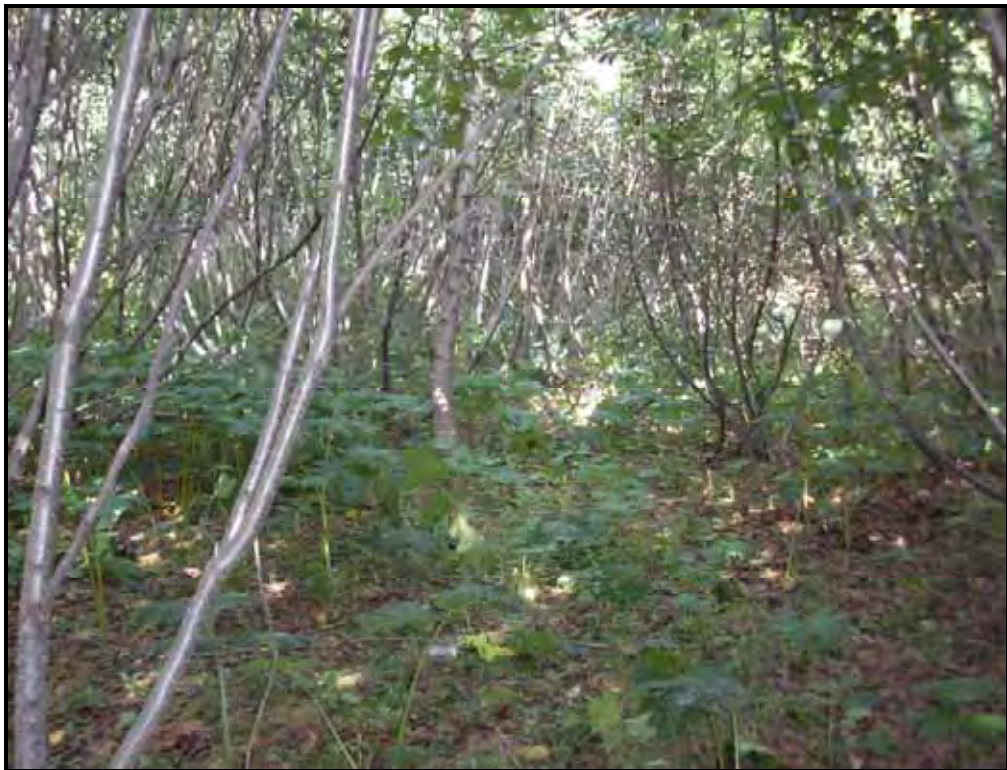
Profile Description: (Describe to the depth needed to document the indicator.)							
Depth (inches)	Matrix		Redox Features			Texture	Remarks
	Color (moist)	%	Color (moist)	%	Type ¹		
0 - 6	10YR2/2	100	N/A				mixed organics
6+							fractured bedrock

<input type="checkbox"/> Mat or Crust of Algae or Marl (B4)		<input type="checkbox"/> Geomorphic Position (D2)
<input type="checkbox"/> Iron Deposits (B5)		<input type="checkbox"/> Shallow Aquitard (D3)
		<input type="checkbox"/> Microtopographic Relief (D4)
		<input type="checkbox"/> FAC-Neutral Test (D5)
Field Observations:		
Surface Water Present?	Yes _____ No <input checked="" type="checkbox"/>	Wetland Hydrology Present? Yes _____ No <input checked="" type="checkbox"/>
Water Table Present?	Yes _____ No <input checked="" type="checkbox"/>	
Saturation Present? (includes capillary fringe)	Yes _____ No <input checked="" type="checkbox"/>	
Describe Recorded Data (stream gauge, monitoring well, aerial photos, previous inspections), if available:		
Remarks:		
Dry

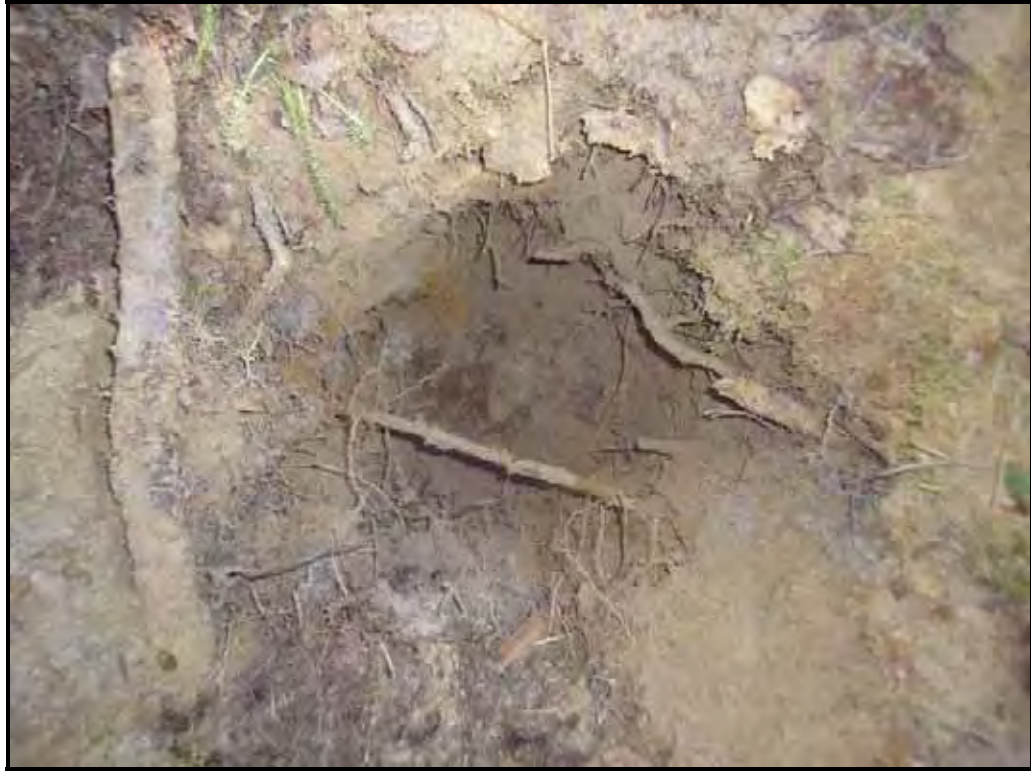
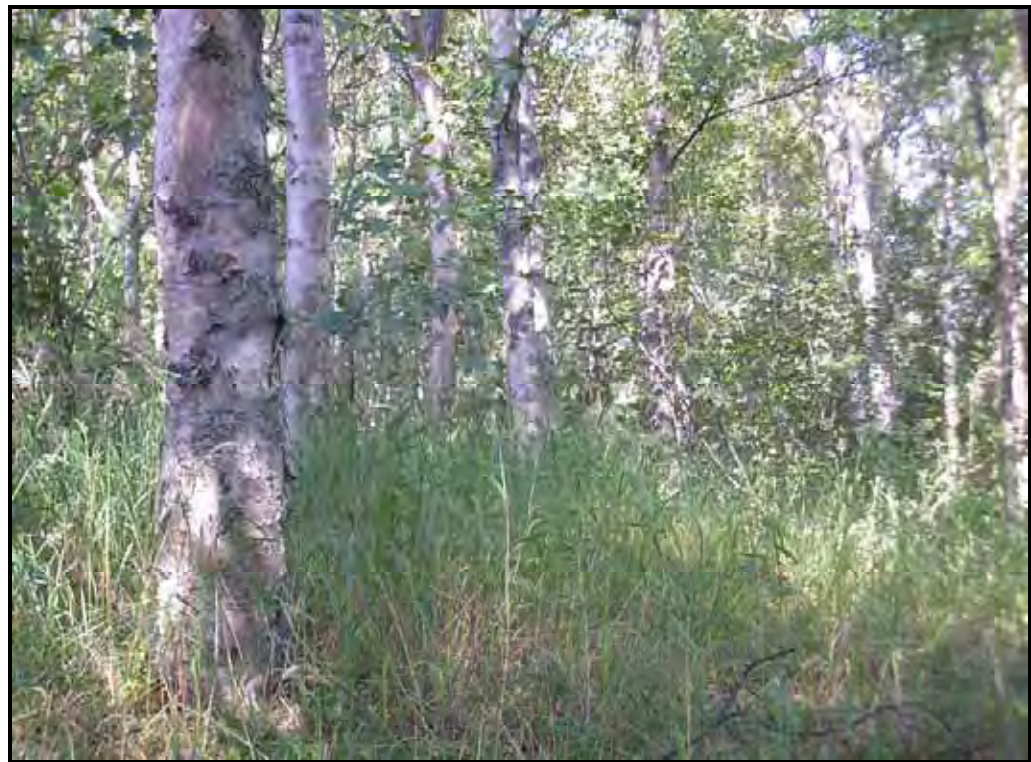
Profile Description: (Describe to the depth needed to document the indicator.)								
Depth (inches)	Matrix		Redox Features				Texture	Remarks
	Color (moist)	%	Color (moist)	%	Type ¹	Loc ²		
0 - 3								Root wad.
3 - 12	10YR4/6	100	N/A				sandy loam	fine sand mixed with ash
12 - 20	10YR4/6	100	N/A				sandy loam	same, with mixed cobbles

Remarks:
Dry

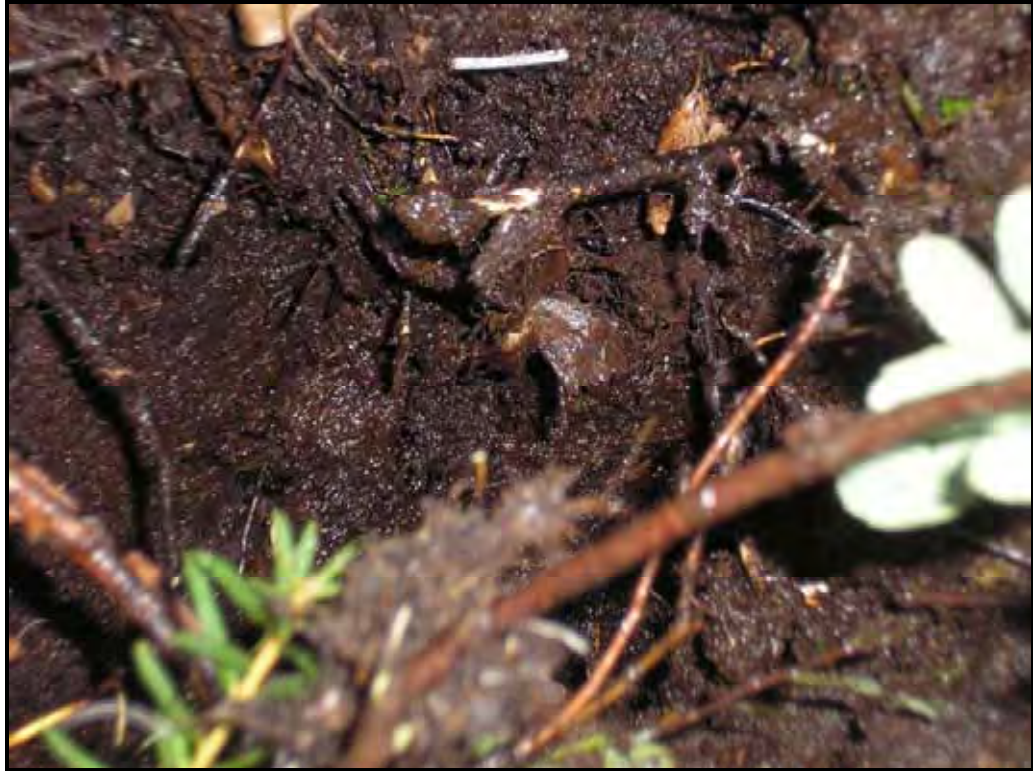
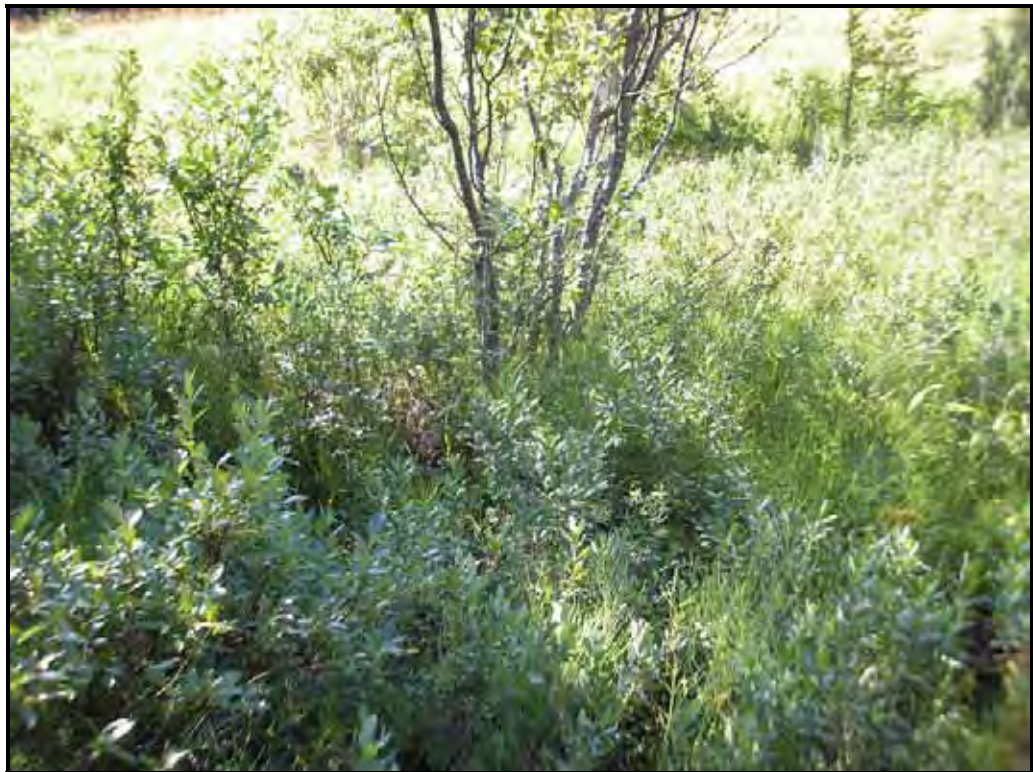
Species (Use scientific names. List all species in plot.)	Absolute % Cover	Indicator Status
1. <u>Picea mariana (t)</u>	20	FACW
2. <u>Betula papyrifera (t)</u>	40	FACU
3. <u>Equisetum arvense (h)</u>	60	FACU
4. <u>Calamagrostis canadensis (h)</u>	20	FAC
5. <u>Picea sitchensis (t)</u>	10	FACU
6. <u>Alnus crispa (s)</u>	50	FAC
7. <u>Ledum decumbens (h)</u>	50	FACW
8. <u>Myrica gale (s)</u>	60	OBL
9. <u>Betula nana (s)</u>	60	FAC
10. <u>Potentilla fruticosa (s)</u>	30	FAC
11. _____		
12. _____		
13. <u>Sphagnum sp. (h)</u>	20	
14. _____		
15. _____		
16. _____		
17. _____		
18. _____		
19. _____		
20. _____		
Total Cover: <u>420</u>		
Plot size <u>20 foot diameter circle</u>	% Bare Ground <u>80</u>	
% Cover of Wetland Bryophytes <u>0</u>	Total Cover of Bryophytes <u>20</u>
